CHEMICAL-VEGETATIVE STABILIZATION  
of an  
ABANDONED CHROMITE TAILINGS POND

Presented to the  
MINERALS WASTE STABILIZATION LIAISON COMMITTEE  
Bonne Terre, Missouri  
May 8, 1973

Timothy C. Richmond  
Manager Land Conservation  
Environmental Engineering Department  
Primary Metals Division  
The Anaconda Company  
Tucson, Arizona

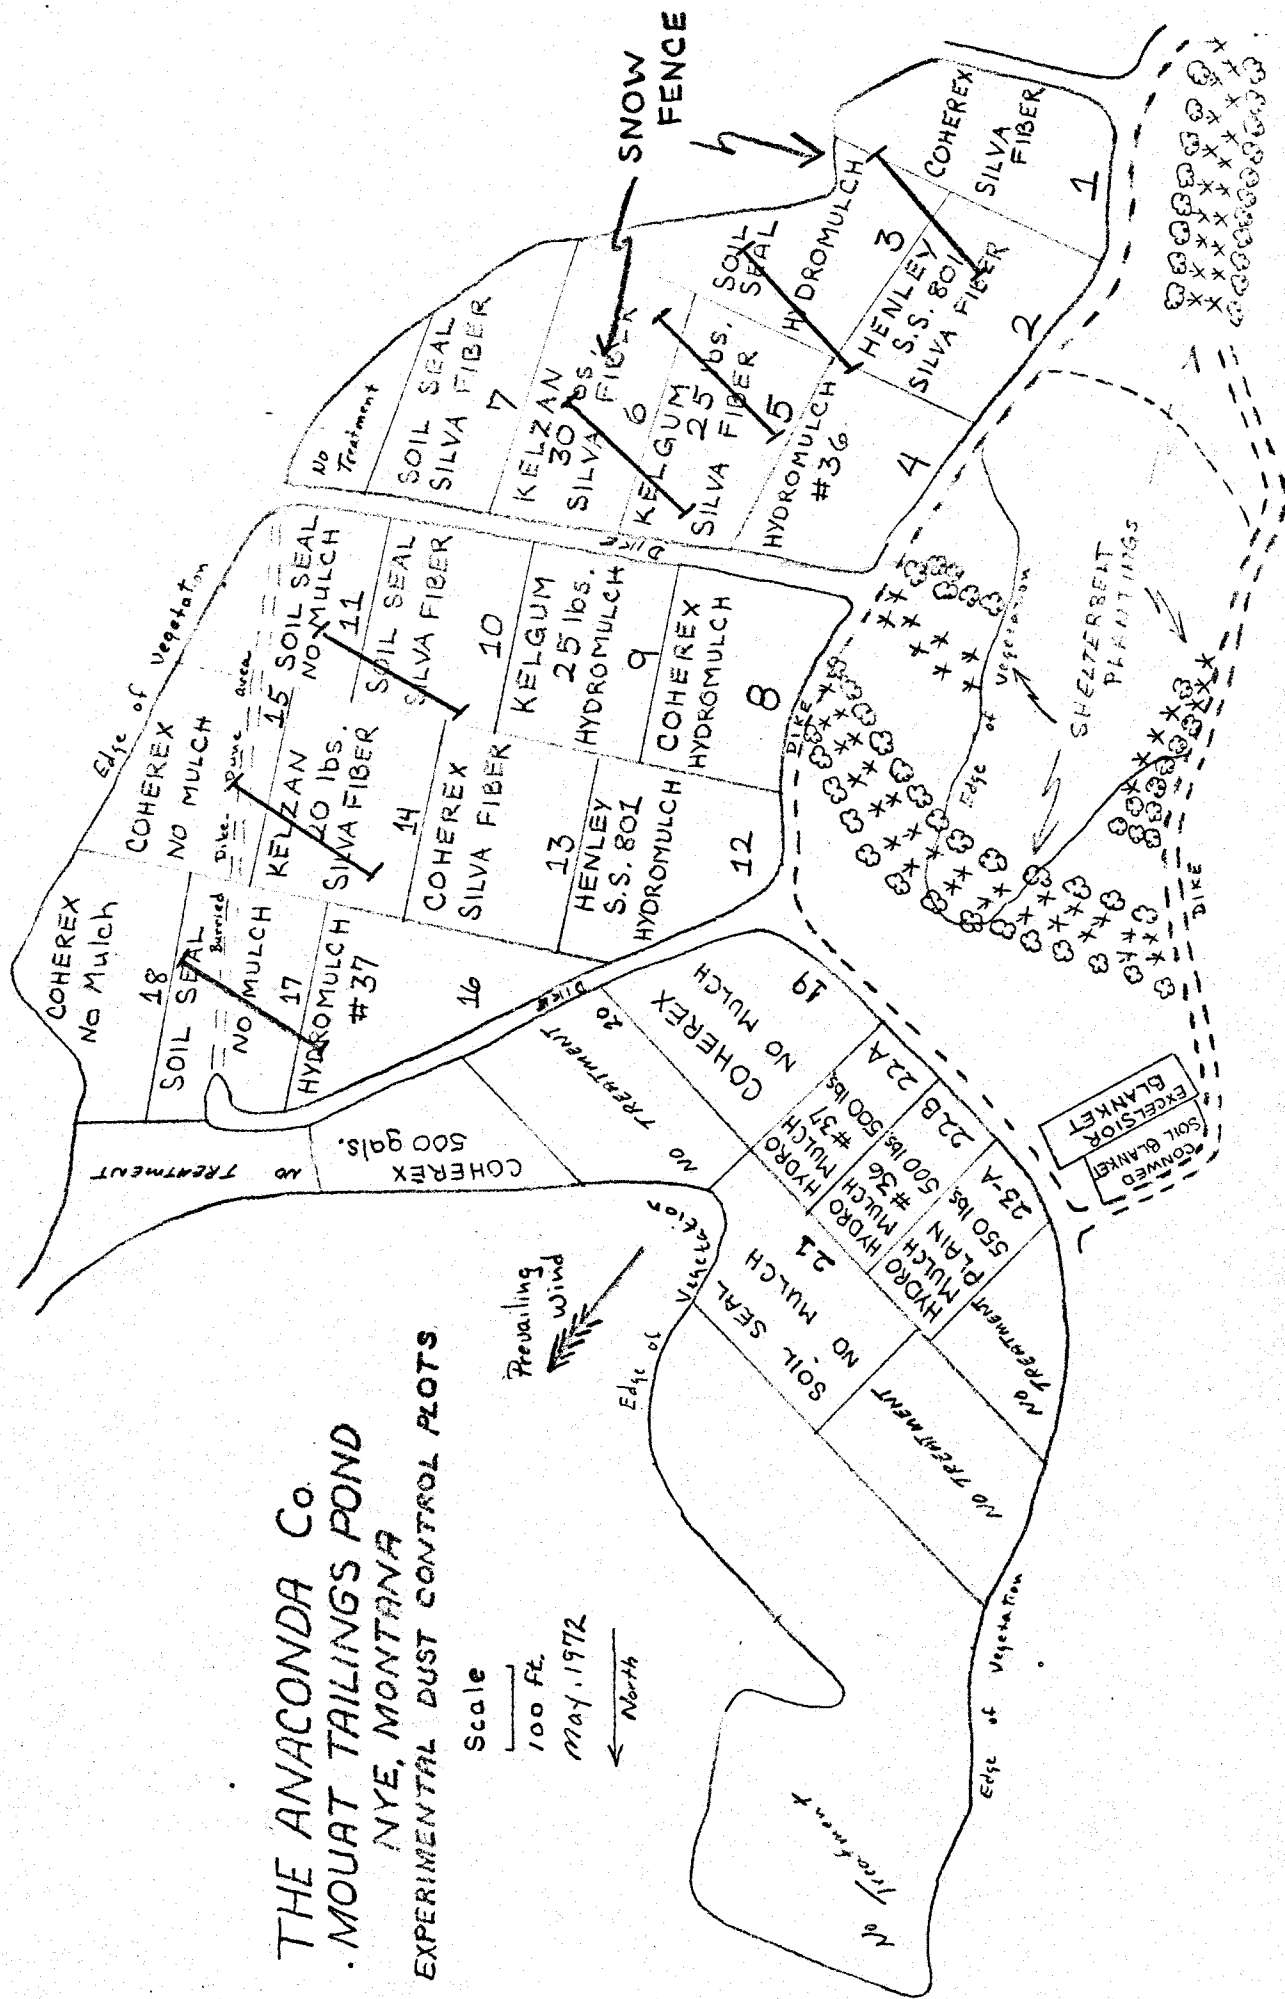
May. 1972

Early in the spring of 1972, 23 one acre plots were staked on the pond surface. Hydroseeding with stabilization chemicals, wood fiber mulch and a seed mixture commenced on May 15 in order to take advantage of the normal June rains. Treatments included Cohex, Soil Seal, Huels Soil Stabilizer 801, Kelzan and Kelgum as stabilizing chemicals, and Conwed and Weyherhaeuser wood fiber mulches. An additional 5800 square feet each of Conwed and American Excelsior Soil Retention Blankets were used. (Appendix III). Where quantities allowed, replicates of each treatment were made to provide more accurate conclusions. (map).
